UNITED STATES DISTRICT COURT
FOR THE DISTRICT OF MASSACHUSETTS

**PLAINTIFFS' AMENDED OPPOSITION
TO DEFENDANTS' MOTION FOR
SUMMARY JUDGMENT**

B. Colgan's Alleged Maintenance Errors and Omissions	10
▪ <i>Events Leading to the Replacement of the Forward Elevator Trim Cable</i>	
▪ <i>Raytheon's Errors and Omissions - Instruction for the Trim Cable Replacement</i>

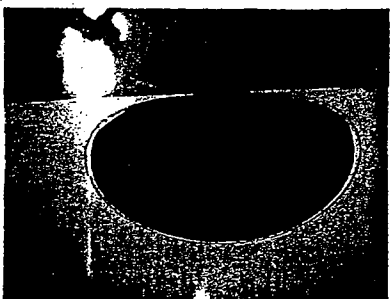
Cabin window – gravel damage

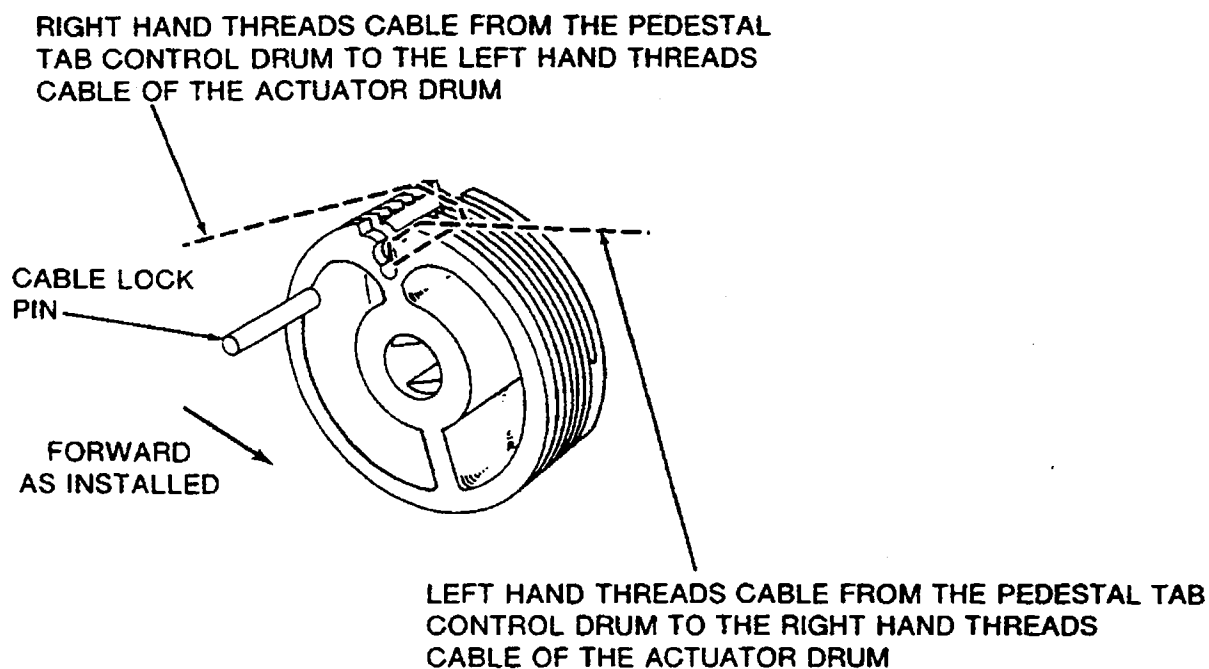
Elevator Tab Control Cable Winding

Notwithstanding the defendant's bald assertions to the contrary, there is no indication that either Colgan, its pilots, or its mechanics were aware of the specific risk posed by the incorrect diagram, Figure 201, contained in the AMM, nor that any of the alleged sophisticated users was aware of that risk or hazard with to *same* extent or with the same quantum of appreciation as the would have been had Raytheon either provided adequate instructions or warned of the risk of relying on the erroneous diagram in the AMM.

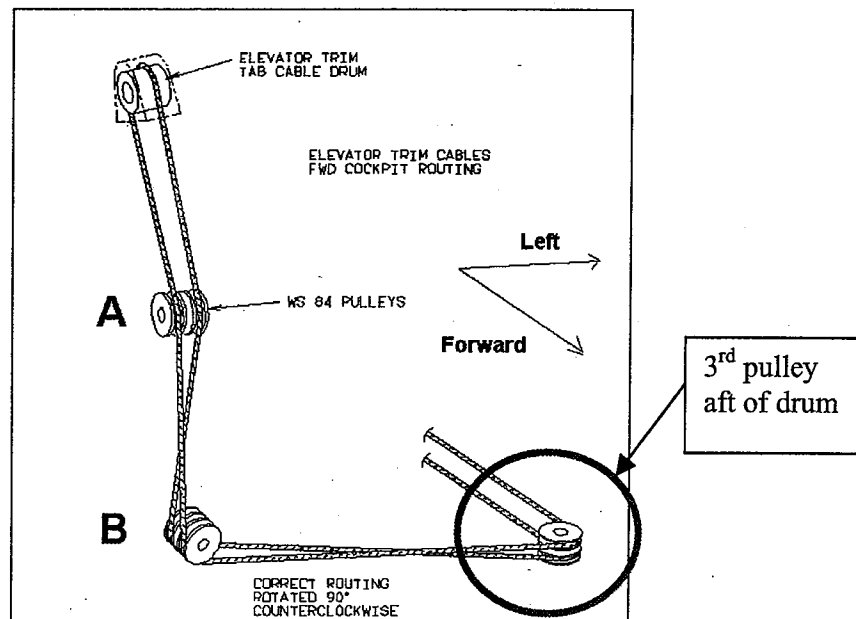
Figure 1 – Detail F from 27-30-04-201

- Before pulling the cables off, he marked the pulleys starting with the 3rd pulley aft of the drum (as circled in figure 1 below), with a “T” for top. This was before the retaining pins were pulled.

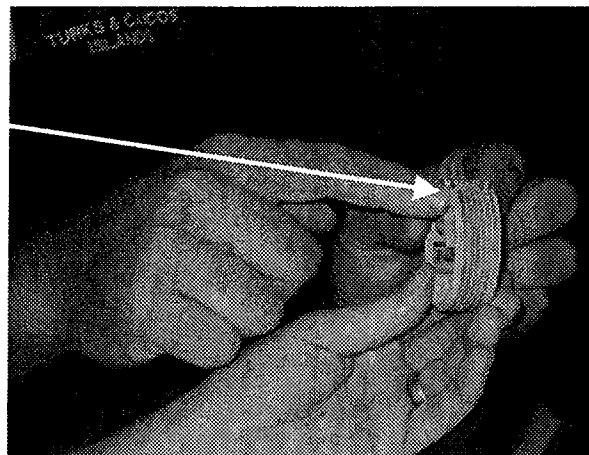
Figure 2 Elevator trim cables

- They then wrapped the drum using diagram 201 ("Elevator Tab Control Cable Winding") from maintenance manual, section 27-30-04-210, as a guide. See picture below (Figure 2) showing where they positioned the left hand threaded cable.

Left hand threaded cable positioned here as shown by mechanic
